64-bit Intel® Xeon® Processor with 800 MHz System Bus (1 MB and 2 MB L2 Cache Versions)

Specification Update

May 2006

Document Number: 302402-021

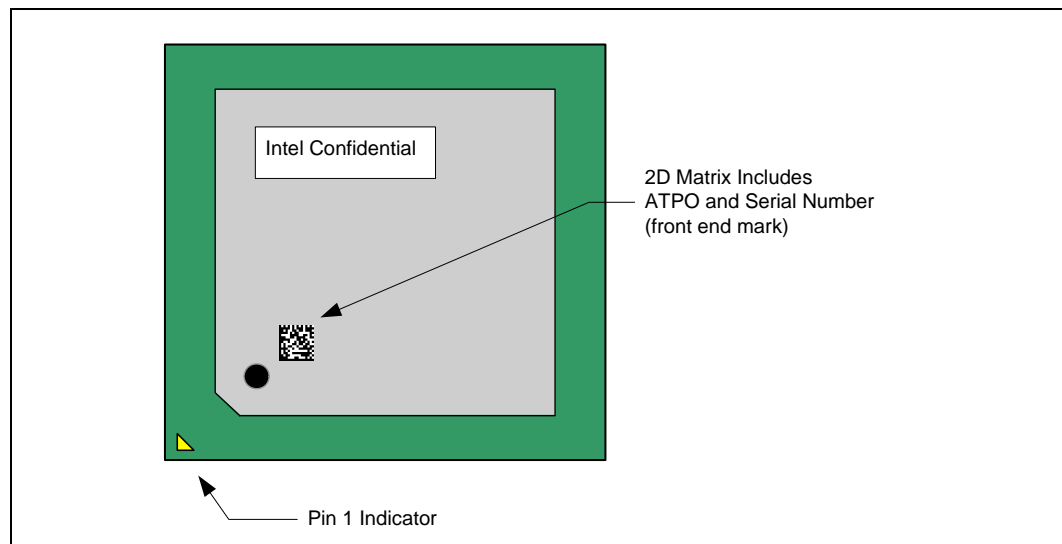
Figure 1. Top-Side Processor Marking Example

64-bit Intel® Xeon® Processor with 800 MHz System Bus (1 MB and 2 MB L2 Cache Versions) Package Markings (604-pin FC-mPGA4 Package)
